AN EVALUATION OF THE FISH RESOURCES OF THE MACKENZIE
RIVER VALLEY AS RELATED TO PIPELINE DEVELOPMENT

Volume II

by R.L. Dryden, B.G. Sutherland, J.N. Stein

Fisheries Service
Department of the Environment

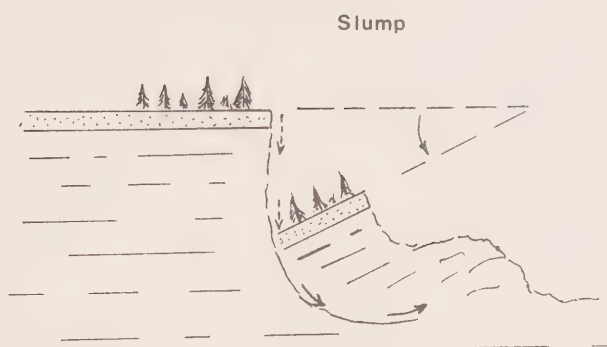
Fig. 1 Slump Mechanics

Slump: The term slump is applied to large masses of bedrock or overburden that slide downward from a cliff, at the same time rotating backward on a horizontal axis. Slumping commonly occurs wherever weak overburden such as flood plain alluvium or glacial deposit has its supporting base removed. Hence it is seen in regions of high riverbanks with undercut bases (Fig. 8),

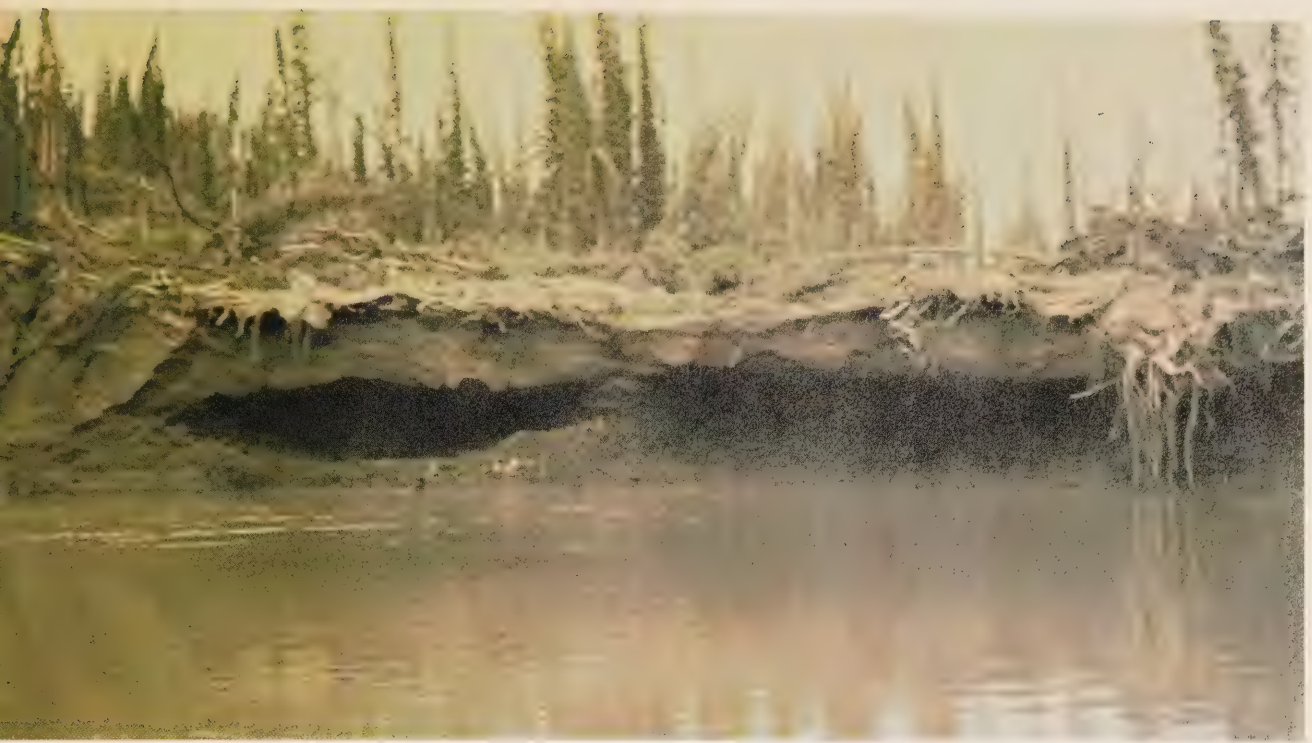
Fig. 2 Deeply undercut riverbank with extensive vegetation mat overhang.

Riverbank failures, if extensive enough, may result in a lack of support for sections of pipeline approaching or crossing a stream (Fig. 2). The resulting rupture could have disastrous effect on fish.

Undercut Riverbanks: Actively meandering rivers will scour out the base of a riverbank, leaving the upper portion of the bank (vegetation mat binds material together) overhanging the river (Fig. 2) Eventually this overhang will drop into the river and carry with it a sudden surge of debris, which may cause problems at downstream structures (Fig. 9).

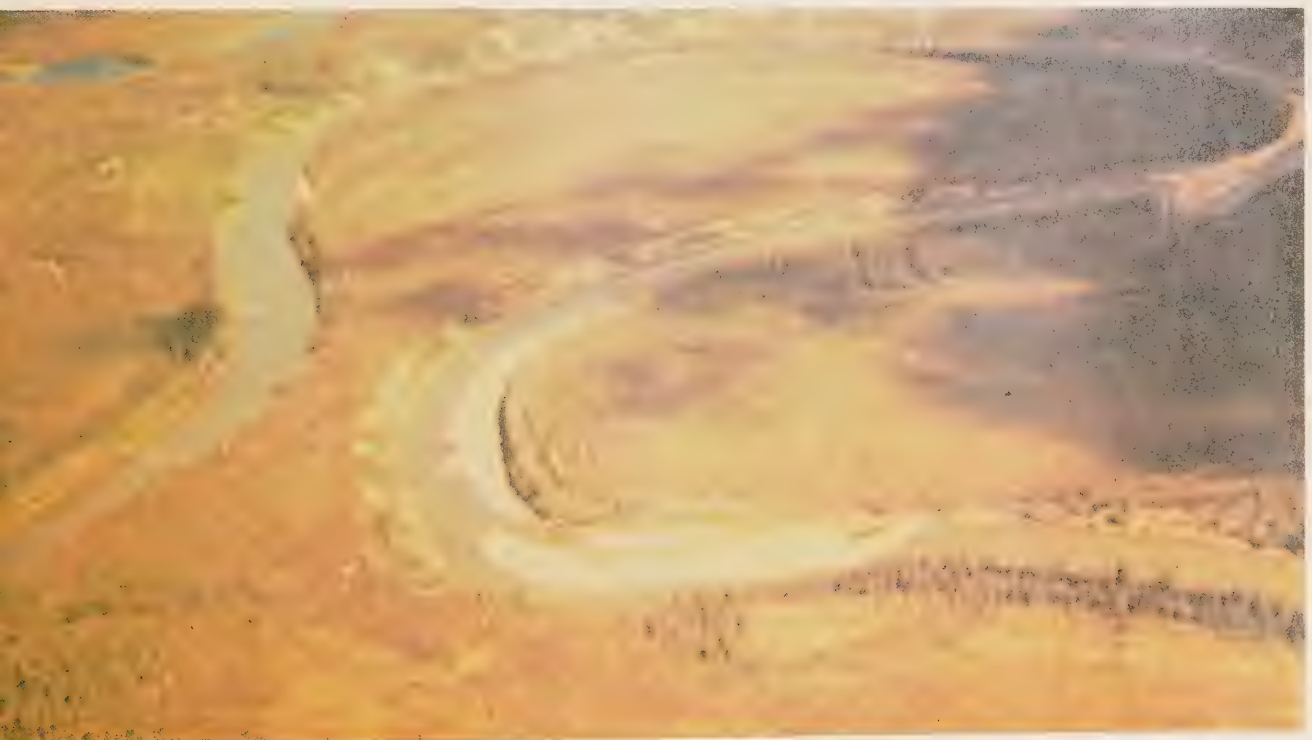
Fig. 3 Large meander loop. An oxbow lake will result when the river channels eventually meet (termed a cut-off) and seal off the meander loop.

Slope angles range from 15°-40° in non-burn areas. Failures are confined to active layer and include slope failures, infinite slope failure solifluction, creep, dry sand runs and mud (flow) slides. Also included in this classification are regions of very active meander containing stream channel cut-offs, oxbow lakes (Fig. 3) and undercut banks. Very marshy or swamp areas are included.

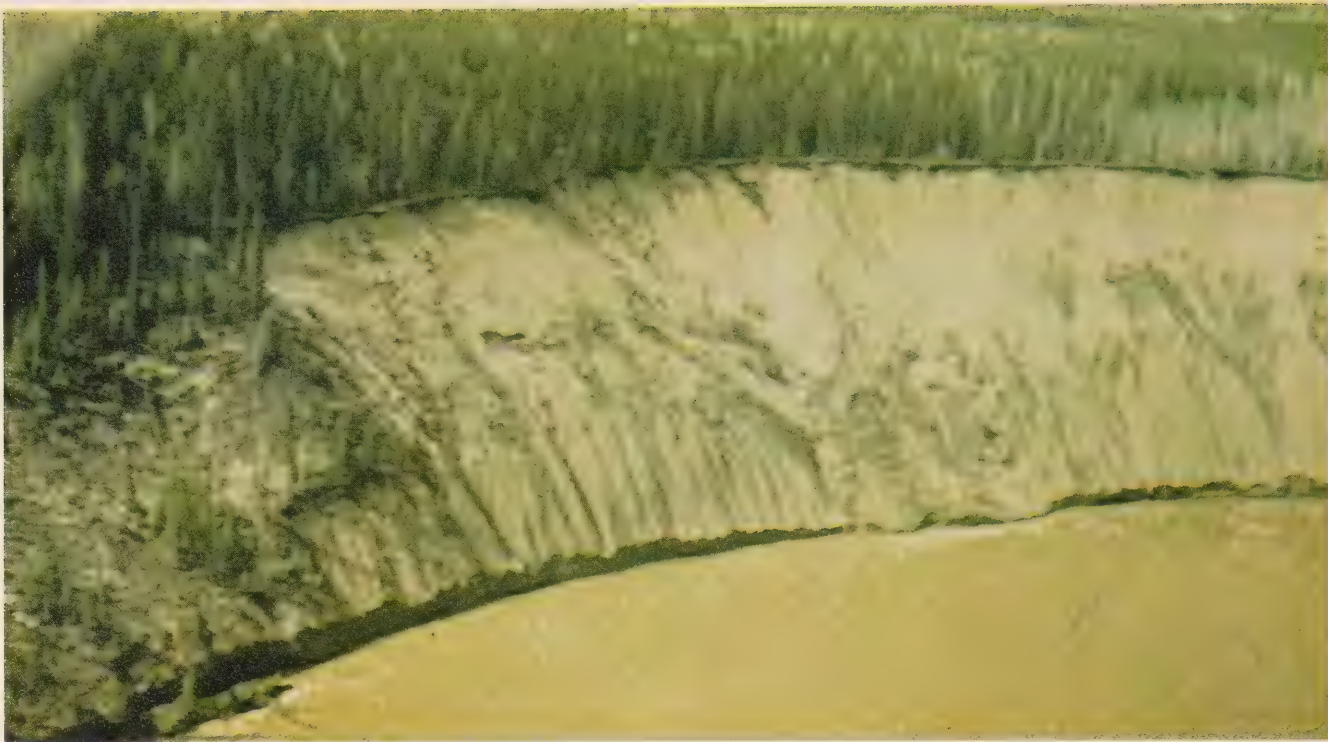
Fig.4 Steep, exposed clay bank. Failures include undercutting, tree falls, gullying and mud slides. Siltation of water is evident. Region would be classified as S₃.

Large scale rotational or translational movement, usually base failures, accompanied by large scale gullying. In permafrost regions, failure planes pass through the active layer and the frozen layer and possibly exit in unfrozen layer below permafrost. This type of slide spreads by lateral regression as a series of slump blocks which can be hundreds of feet wide. Also included in this classification are high, steep banks (slopes 40°) which display a potential for failure (Fig. 4).

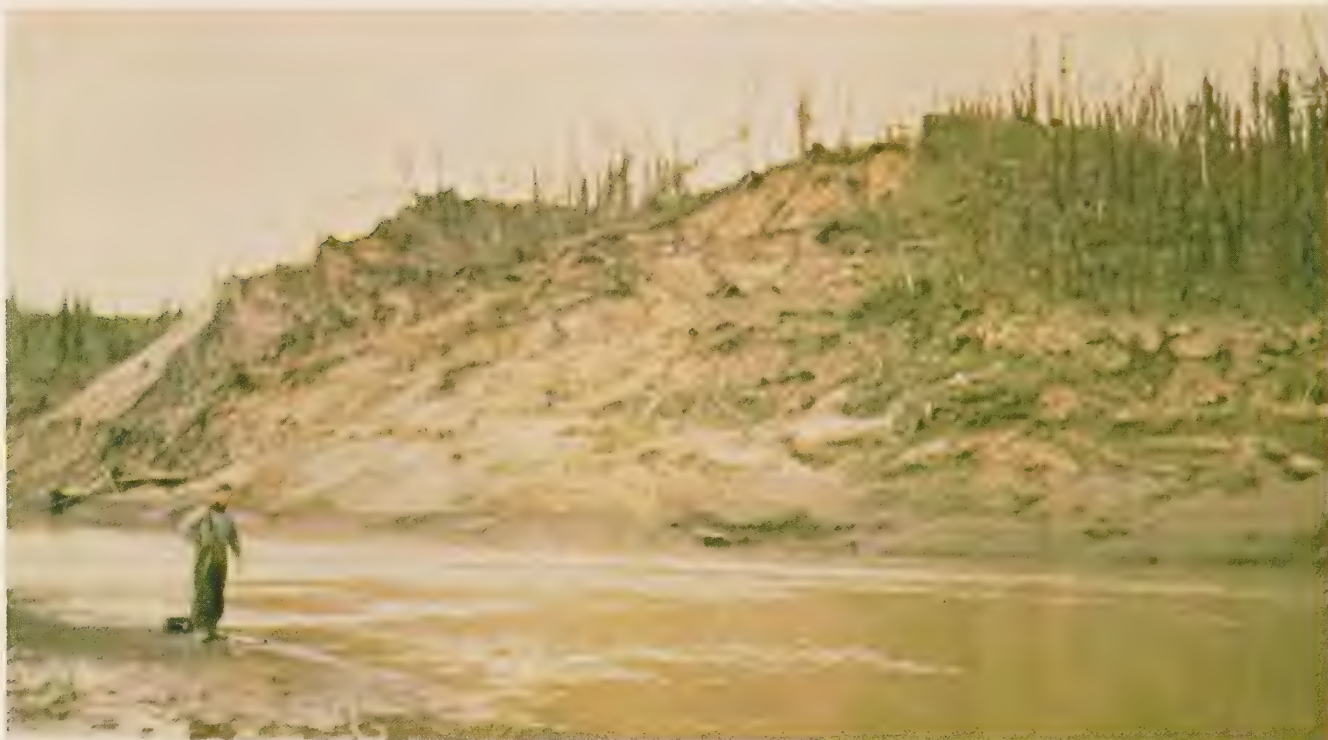
Fig.5 Riverbank erosion resulting from the vegetation mat being destroyed by fire.

Burn Areas: In burn areas, slopes fail on relatively low inclines, such as 5° - 10° . This is a result of the destruction of the insulating organic cover. Without this organic cover, solar radiation increases the depth of the active layer. In addition, the unburnt organic cover provided cohesion to the soils at the ground surface, adding to their natural stability. The newly thawed soil, having a low shear strength, tends to move downslope, carrying the dead organic cover along. (Fig. 5).

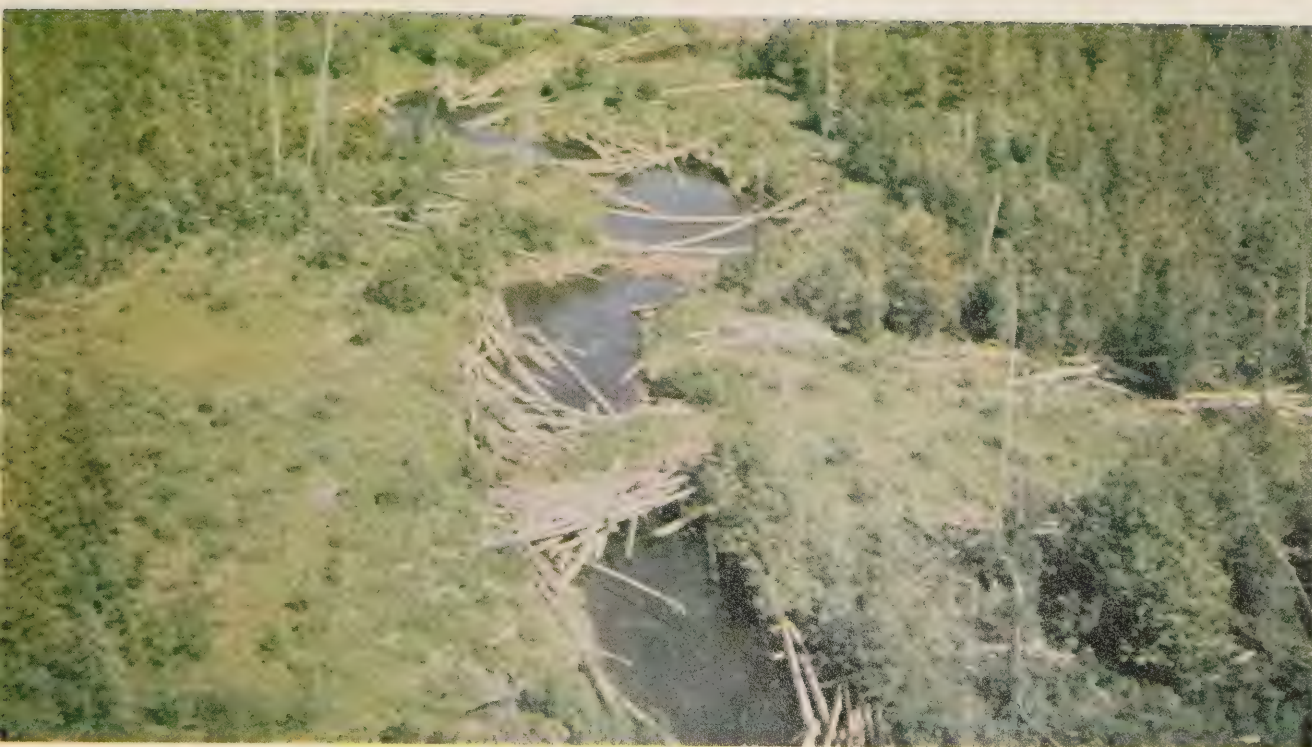
Fig. 6 Stream impassable to fish. Many beaver dams in the background, plus what appears to be the remains of an old winter road in the foreground.

Also marked on the maps were sampling locations, known and suspected spawning areas, stream blockages (Fig. 6), surrounding vegetation, burn areas, etc.

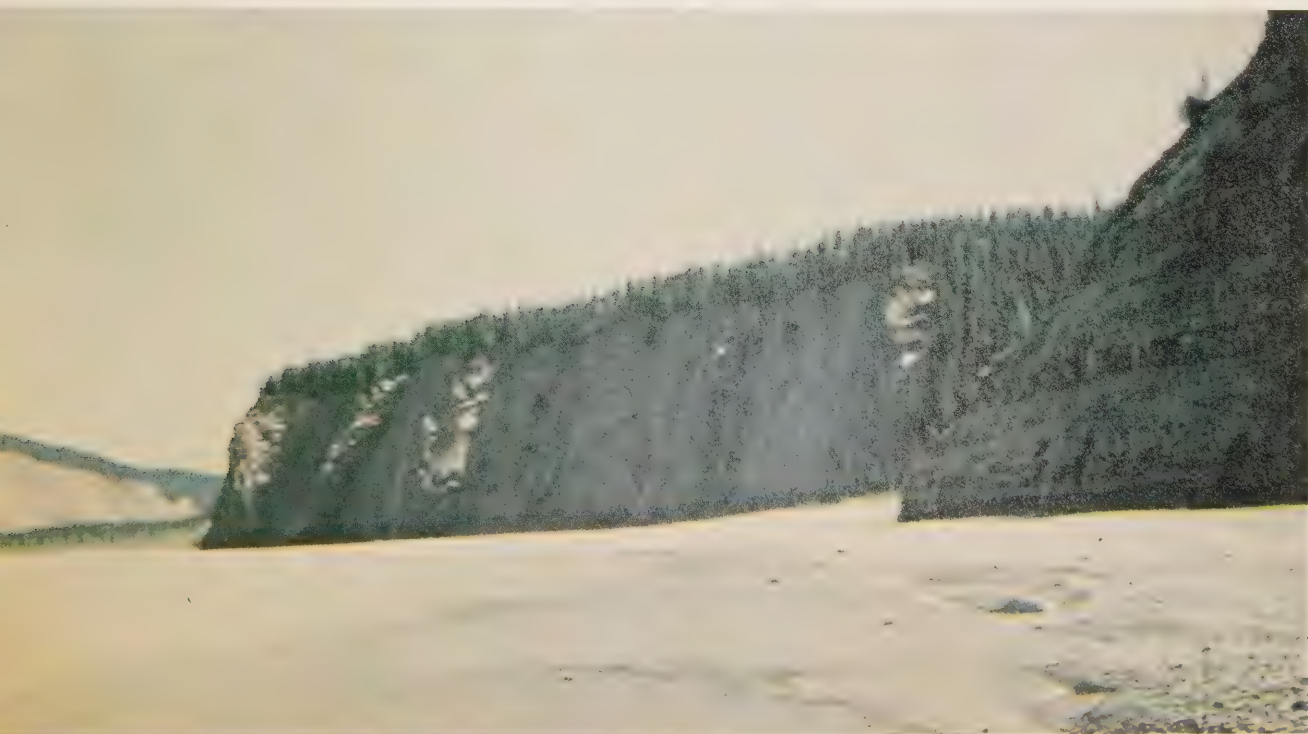
Fig. 7 Rock cliffs showing little evidence of fracture or weathering. Would be classified as R_1 .

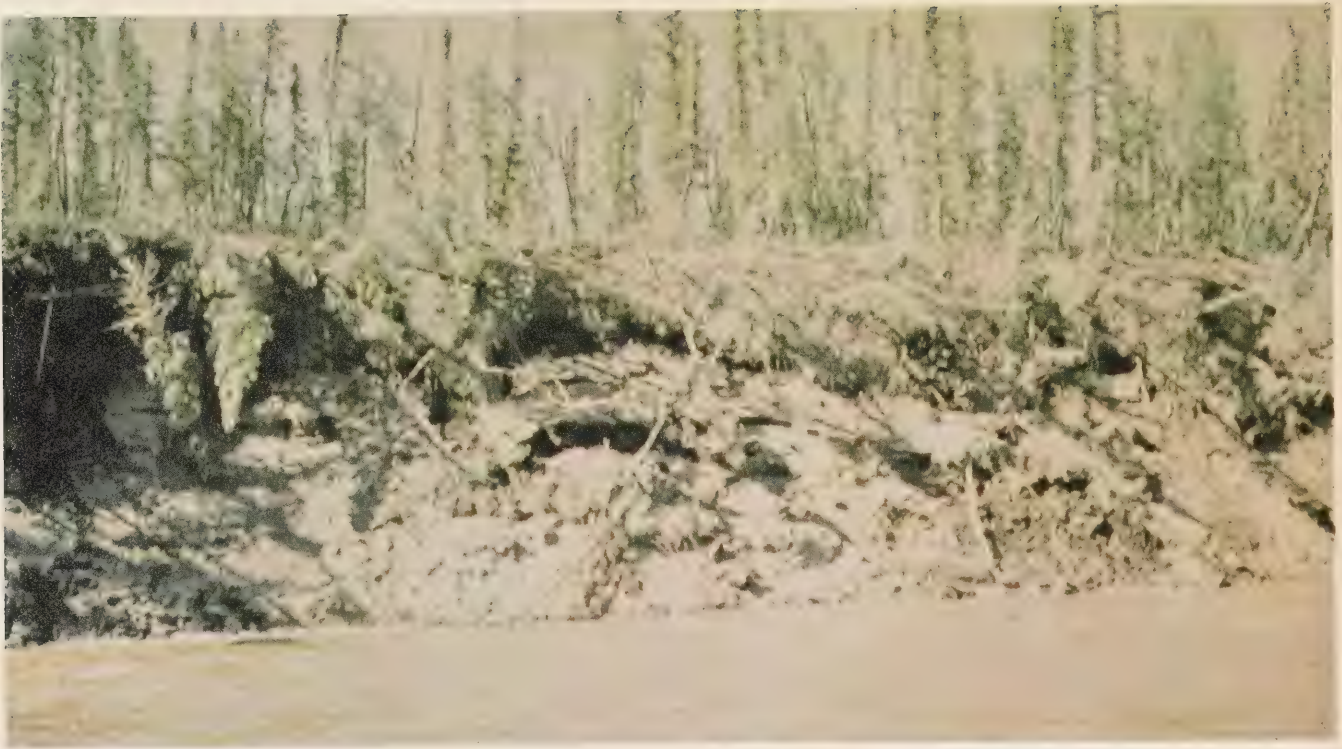
Fig. 8 High-water damage. Failures include undercutting and minor slumping.

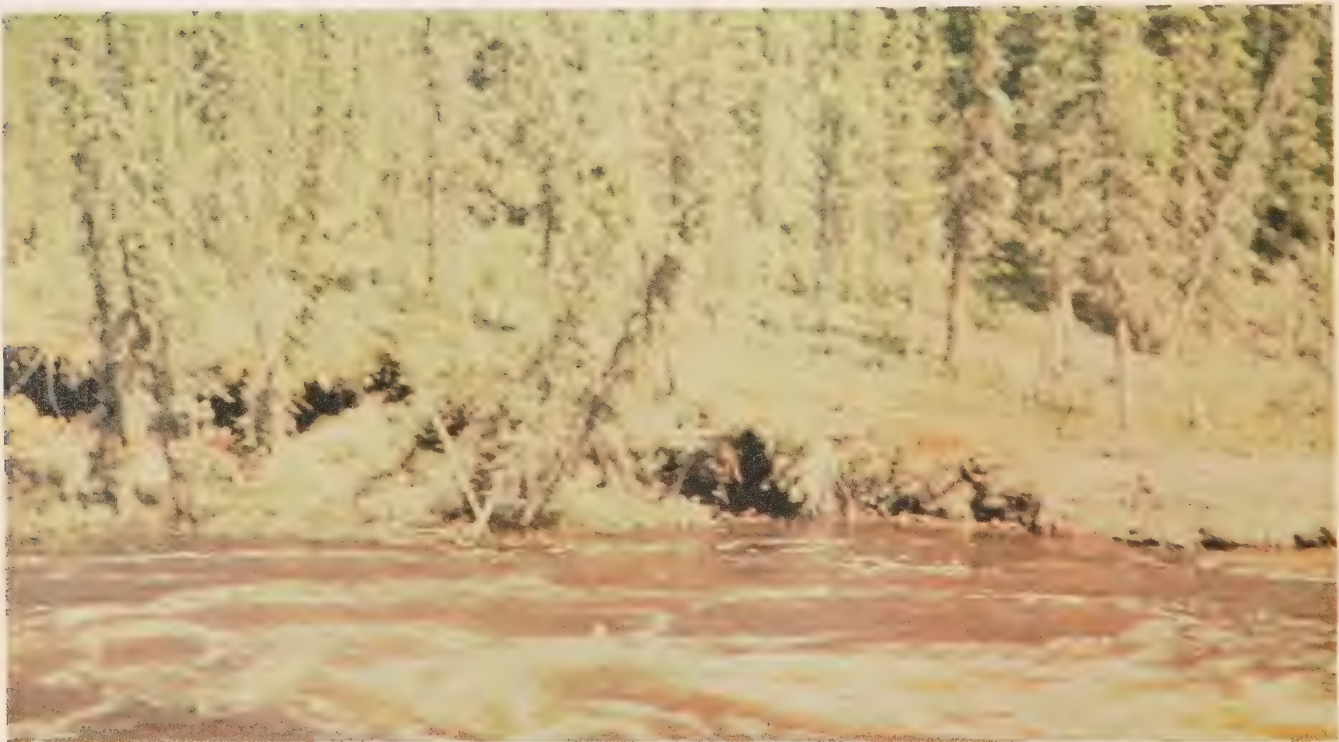
Fig. 9 Riverbank collapse resulting from undercut. The leaning trees are sometimes referred to as "drunken trees."

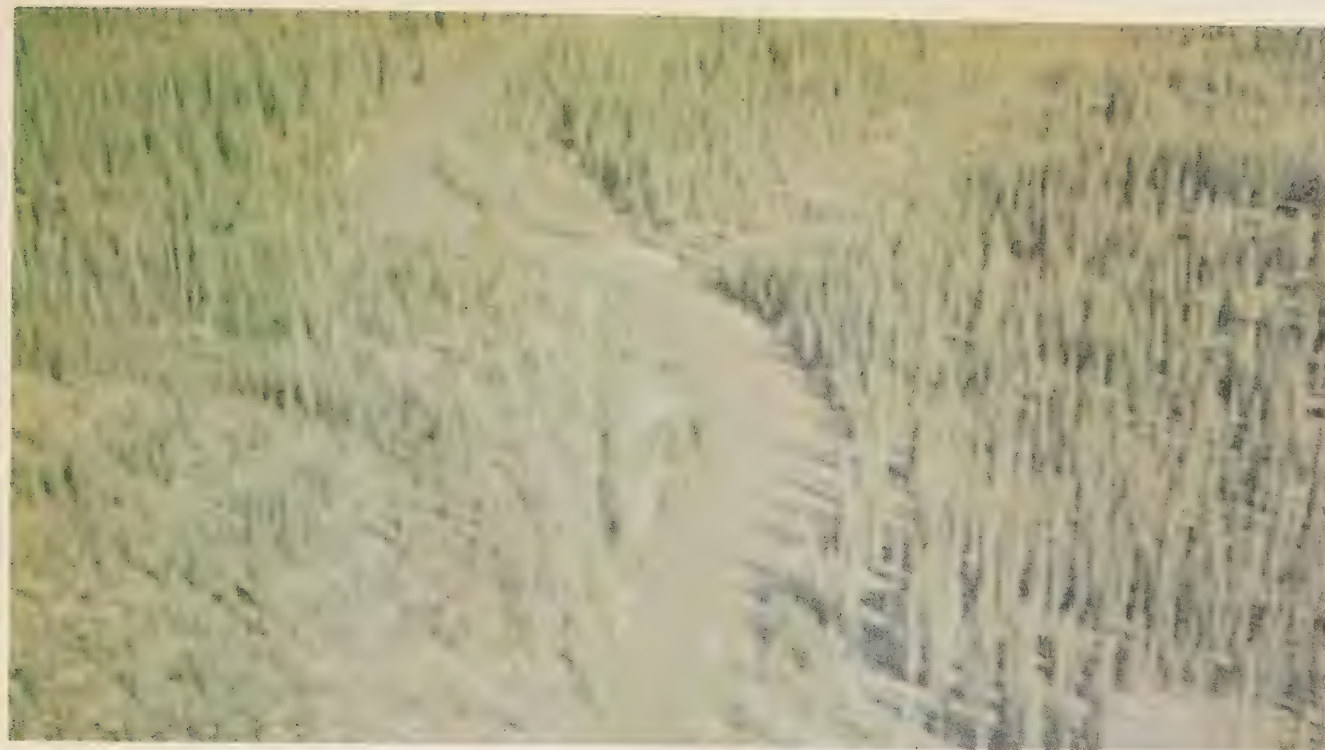
Fig. 10 Stable crossing area, S_1 condition.

Low angle slopes, generally 15°, no failure observed, well vegetated. Typical river would be one which crosses a wide, inactive (heavy spruce growth) flood plain, has low, well vegetated banks, little meander, level or gently rolling surroundings with a heavy tree growth (Fig. 10).

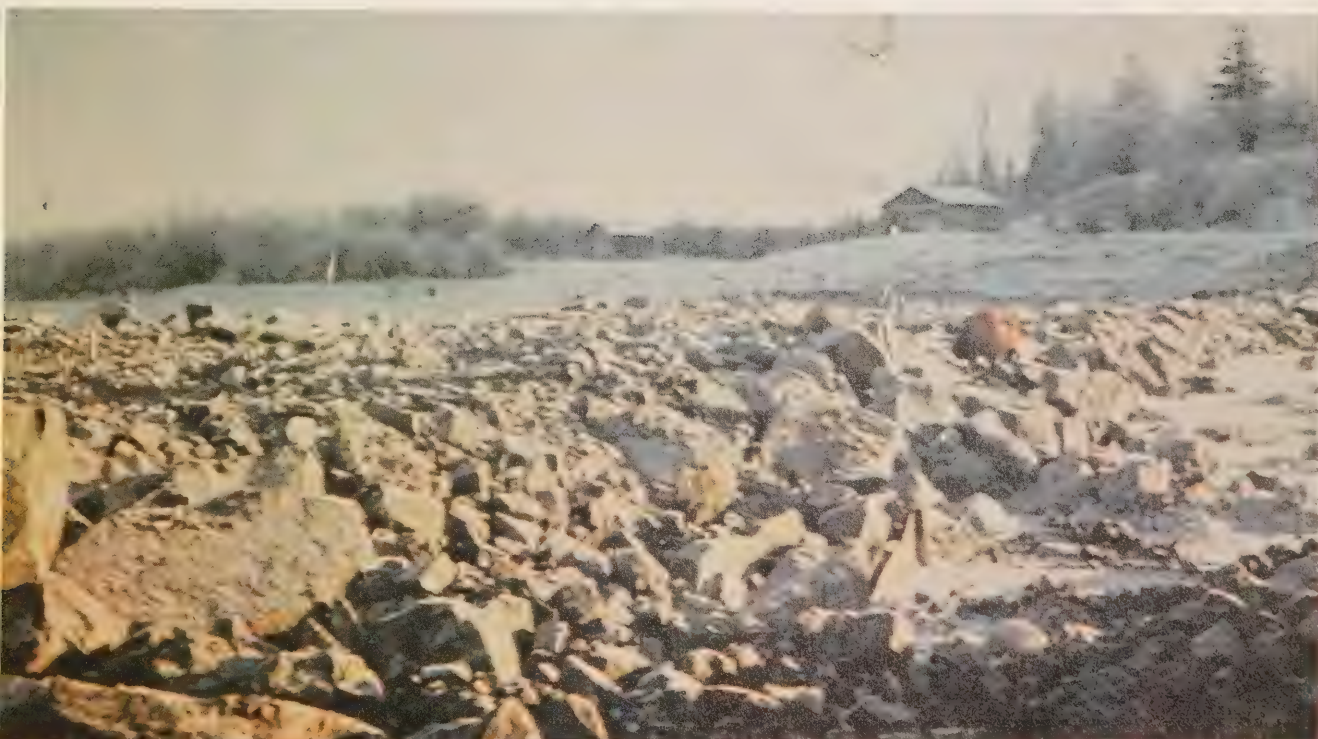
Fig.11 Rip rap material for the protection (from water damage) of stream crossing structures. This size of rock will be in much demand.
